HIGH PRESSURE SPRAYING MAY CAUSE THE ELBOW SADDLE TO ROTATE AND WORK THEIR WAY OFF THE TL START GROW UNIT. NOTE ILLUSTRATIONS 1, 2 & 3.

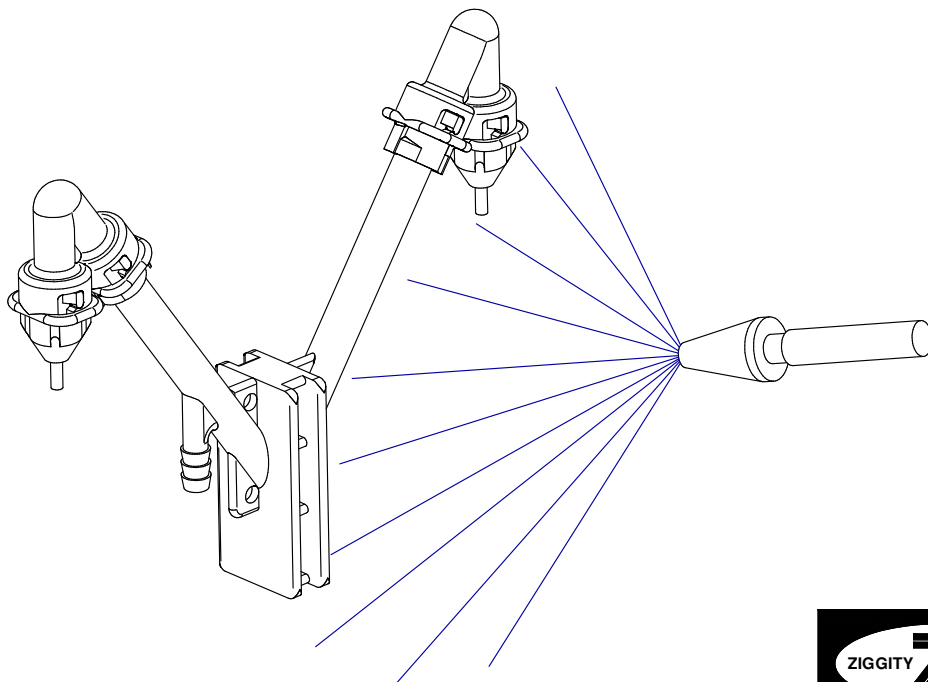
4

NOTE ILLUSTRATION 4.

- 1.) USING A WIDER, LESS CONCENTRATED SPRAY PATTERN
- 2.) NOT DIRECTING THE SPRAY DIRECTLY AT THE ELBOW SADDLE
- 3.) CREATING SUFFICIENT DISTANCE BETWEEN THE SPRAY NOZZLE AND ELBOW SADDLES
